# Luggage Damage Assessment Report

Prepared for claim submission · Independent assessment

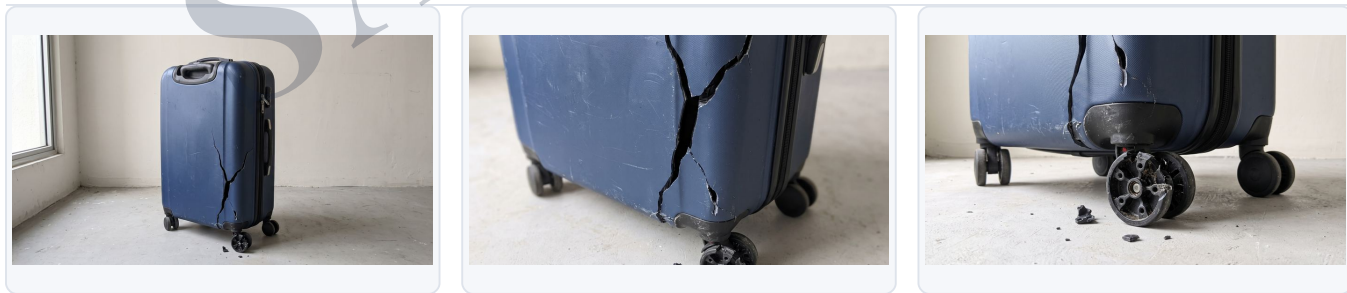
The rear right wheel and housing assembly has sheared cleanly from its axle mount, and the housing itself is cracked and visibly deformed outward, consistent with a sharp, high-energy impact rather than gradual wear. The telescopic handle's inner tube is bent along its lower third and no longer retracts or locks in the extended position. A through-thickness fracture approximately 90mm in length runs from the damaged wheel housing into the lower shell panel, following the moulded seam.

Repairing the wheel housing in isolation would not restore the case to a serviceable condition while the handle remains jammed and the shell fracture remains open, and a polypropylene shell of this construction cannot be re-bonded at a load-bearing seam without a material loss of impact resistance. Taken together, the extent and combination of the damage make repair impractical relative to the value of a comparable replacement case of this make and age. We recommend the item be treated as beyond economical repair.

**Beyond economical repair**
